4 WARRINGTON DAM, BUCKS COUNTY
PENNSYLVANIA

5
6 PHASE I INSPECTION REPORT
NATIONAL DAM INSPECTION PROGRAM.

PHASE I INSPECTION REPORT
NATIONAL DAM INSPECTION PROGRAM

Name of Dam:	Warrington Dam
County Located:	Bucks County
State Located:	Pennsylvania
Stream:	Little Neshaminy Creek
Coordinates:	Latitude 40° 13.6'
	Longitude 75° 9.6'
Date of Inspection:	23 April 1979

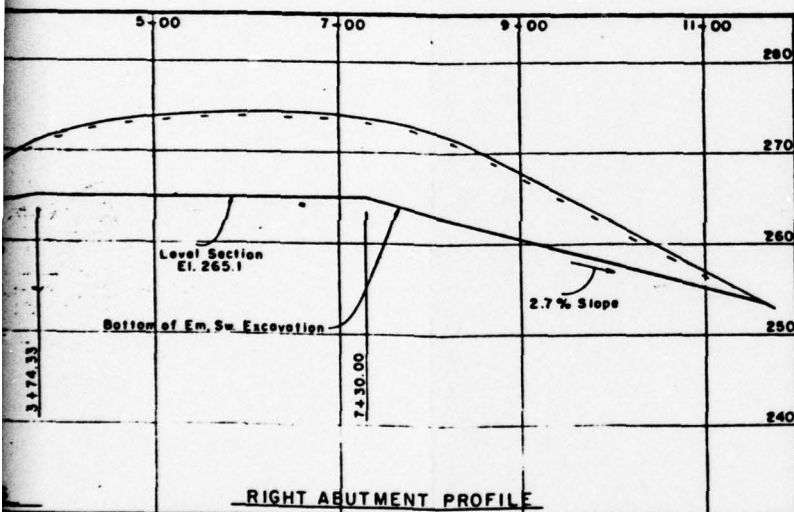
PLATE 10

Generally good condition, minor sloughing on left side of left spillway. Vegetative cover on floor of left spillway needs improving.	
--	--	--
